Manhole Inspection Summary

Manhole # S25GG1034MH

Location Address: **1020 41ST ST**

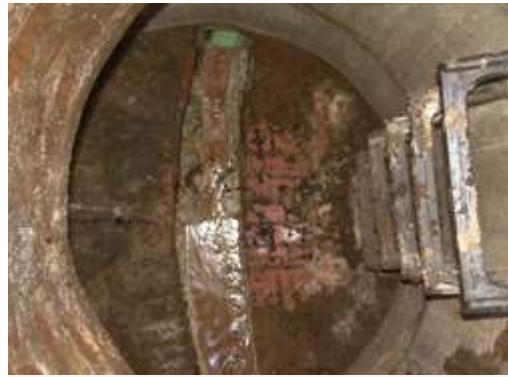
Top View

Evidence of surcharge - Bench debris.
Channel debris.

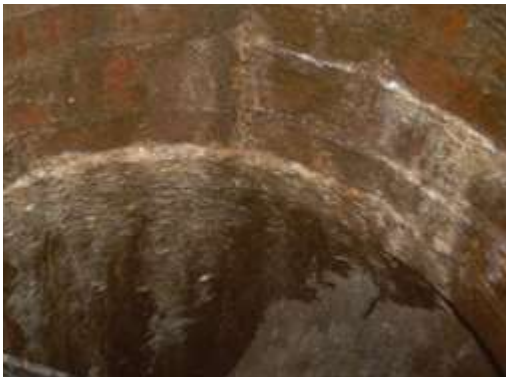
Defect

Frame leaks. Adjustment infiltration.

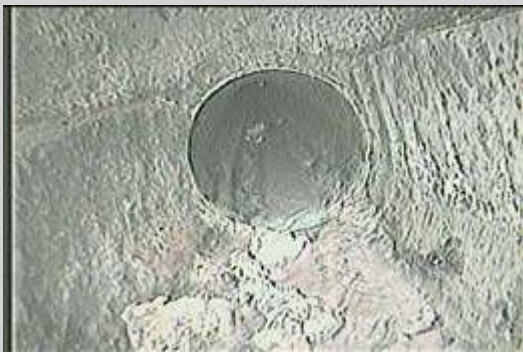
8 in. Circular Gravity Sewer Pipe Out @ 12 O'Clock

Deposits: ☐ None ☐ Mud ☐ Sludge ☐ Debris ☒ **Grease**

Silt Depth: **0** (in.) Deposits Extent: **Medium**

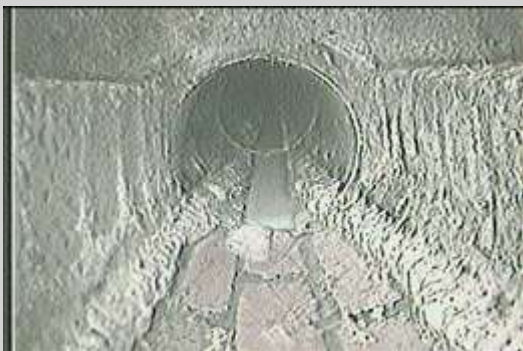
8 in. Circular Gravity Sewer Pipe In @ 5 O'Clock

Deposits: ☐ None ☐ Mud ☐ Sludge ☐ Debris ☒ **Grease**

Silt Depth: **0** (in.) Deposits Extent: **Medium**
